# Analyzing the Root Cause of Clamp Galling Required Customer Cooperation

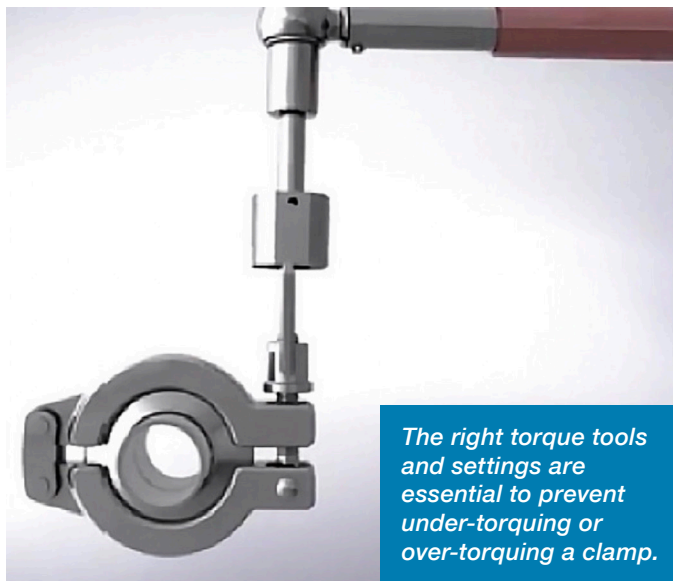
*The right torque tools and settings are essential to prevent under-torquing or over-torquing a clamp.*

The first was the way maintenance personnel torqued the nuts that held the clamps in place around the ferrules. Under-torquing leads to a gasket that's under-compressed, making the joint prone to leaking and allowing for entrapment areas between the gasket and ferrule. When over-torqued, a clamp's bolts and nuts can fuse or bind to each other, so they are literally "cold-welded" together. Over-torqued clamps also exert too much friction and pressure on the connection, which can lead to gasket intrusions into the connection, interfering with the flow of

Through working with our local distributor, we soon discovered that our customer's maintenance personnel had no established torquing procedure or specifications to follow. That meant that any clamp could be significantly over-torqued or under-torqued, depending on the physical strength of the person who closed it. Although this wasn't determined to be the root cause of the customer's galling problem, it led them to develop a validated and approved set of torquing procedures and settings, as well as to purchase tools for applying and checking for the proper amount of torque.
