# Analyzing the Root Cause of Clamp Galling Required Customer Cooperation

A few years ago, one of L.J. Star's major pharmaceutical manufacturing customers in New England began reporting galling problems with clamps. In a galled clamp, the threads of the bolt and nut become fused and seized together, making it extremely difficult or impossible to open the clamp to inspect or service the connection. L.J. Star had a decades-long business relationship with this customer, which made quickly tracking down the source of the problem and correcting it a high priority.

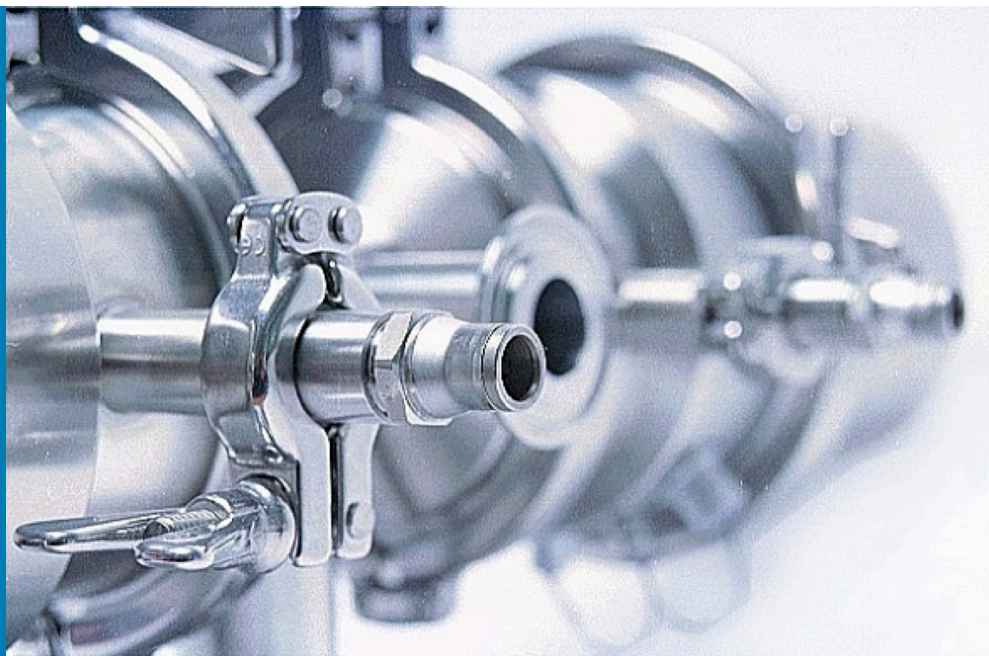
After further research, we concluded the source of the problem could be traced to the materials from which the bolt and nut were formed. Like the rest of the clamp, they were made of 316 grade stainless steel. Being made of the same material caused them to fuse and seize when over-torqued or exposed to high temperature, friction and pressure. That meant that the key to the solution was making sure that the bolt and the nut were made of two different types of steel of differing levels of hardness. However, we realized that if the nut was formed of the harder material, it would strip the bolt if it was over-torqued, which would have required scrapping the entire clamp. Preventing galling required forming the bolts out of harder material that wouldn't be deformed by over-torquing the nut.

*SH Series clamps with the new anti-galling option are constructed with bolts formed from Nitronic 60 stainless steel alloy to withstand over-torquing and sodium hydroxide-based cleaning solutions. They are now commercially available for use in pharmaceutical and biotechnology processing operations, as both original equipment and as replacement parts.*

We recommended several alternative bolt materials, which our customer considered before countering with their own suggestion, Nitronic® 60 stainless steel alloy. This hard, galling-resistant material was already being used in their production equipment, so it offered the advantage of not requiring a lengthy qualification process. We produced samples of a variety of clamps, some with Nitronic 60 bolts and the softer 316 grade stainless steel for the wing nut or hex nut. After repeated testing of how the experimental clamps performed in actual use and how they reacted to the customer's part washing process and new torquing procedure, the clamps with the Nitronic 60 bolts proved themselves substantially more resistant to galling in use, even when over-torqued.
