A few years ago, one of L.J. Star's major pharmaceutical manufacturing customers in New England began reporting galling problems with clamps. In a galled clamp, the threads of the bolt and nut become fused and seized together, making it extremely difficult or impossible to open the clamp to inspect or service the connection. L.J. Star had a decades-long business relationship with this customer, which made quickly tracking down the source of the problem and correcting it a high priority.

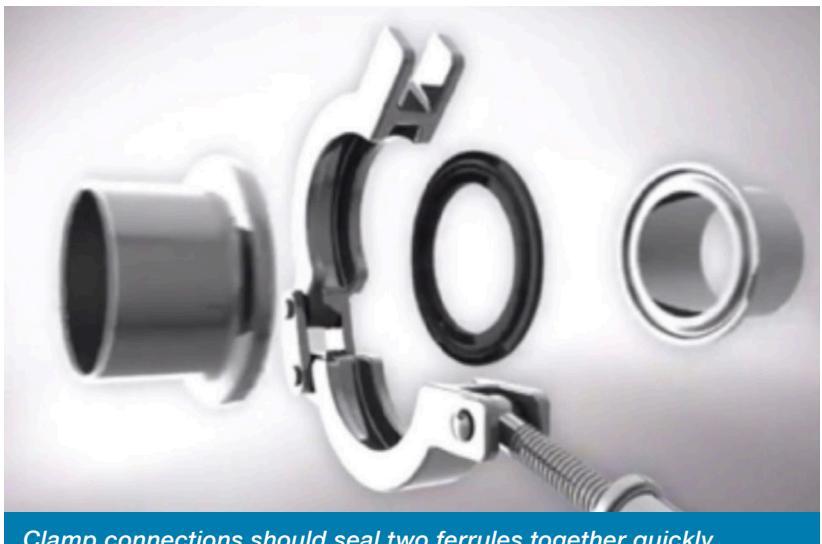
Clamp connections should seal two ferrules together quickly, securely and without creating pockets that allow particles to collect.
