Video Monitoring Improves Brewery Trub Removal and Prevents Cross-tamination of Batches

Brewery product quality requires close attention to process variables throughout the production cycle. The use of a sight-glass camera on process vessels can help prevent product loss.

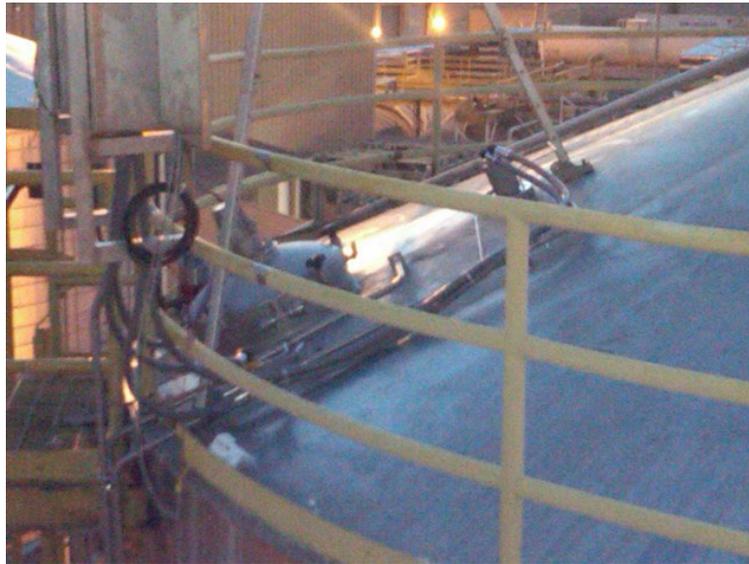
Figure 1. Brewery whirlpool tank where the video camera is installed.

The application environment for the camera was the main factor in other companies declining to submit a bid. The camera must be mounted on top of the whirlpool tank, which places it outdoors and exposed to the full range of environmental conditions. In addition to heat from the sun, heat from the whirling wort is transmitted to the camera through the sight-glass assembly. This can raise the temperature of the camera housing to more than 100°C.

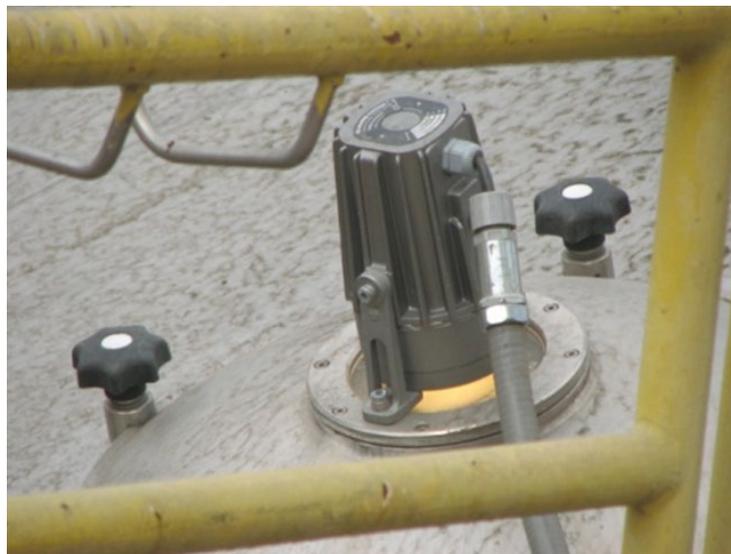
Figure 2. High intensity discharge lamp lights the inside of the whirlpool tank.

A Lumiglas® Model K15 VISULEX color video camera supplied by L.J. Star was installed on the existing sight-glass in the top of the whirlpool tank. A second sight-glass with a high intensity discharge lamp was installed to provide sufficient continuous illumination inside the tank for the camera. Then initial testing was conducted to see how the system performed. Two problems were uncovered during the first few trial runs. First, condensation from the whirling wort collected on the sight-glass, obscuring the camera's view inside the tank. Second, the temperature of the camera housing rose so high that there were periodic faults in the transmitted video image.

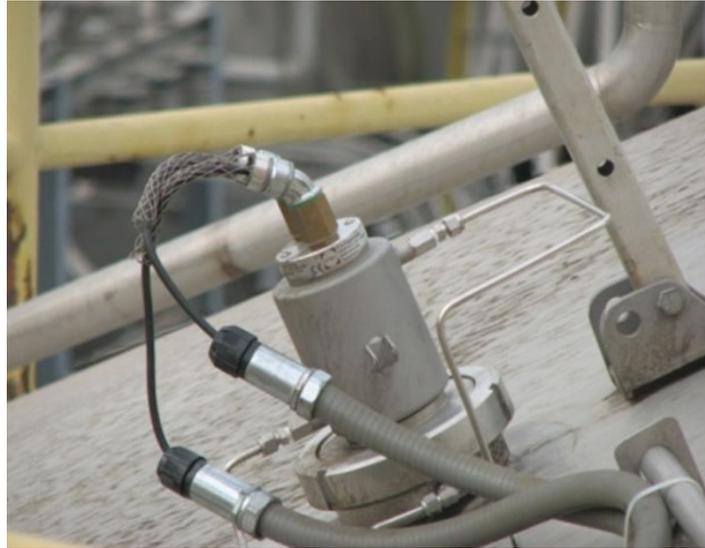
Figure 3. Camera installed in an air-cooled housing.

To solve these problems L.J. Star technicians replaced the standard sight-glass with one that had a hydrophobic coating. This allowed the glass to shed condensation more easily. Then the camera was installed in a stainless steel air-cooled housing. Airflow (5–8 psi) was controlled by a solenoid-operated valve tied into one of the brewery's PLC systems. The PLC logic was programmed to turn off airflow whenever there was no process activity for eight hours.
