# Analyzing the Root Cause of Clamp Galling Required Customer Cooperation

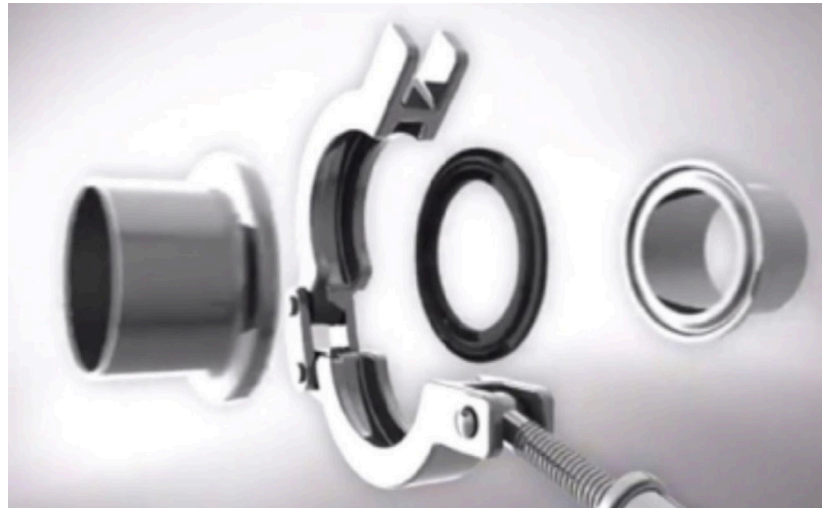
*Clamp connections should seal two ferrules together quickly, securely and without creating pockets that allow particles to collect.*
