A few years ago, one of L.J. Star's major pharmaceutical manufacturing customers in New England began reporting galling problems with clamps. In a galled clamp, the threads of the bolt and nut become fused and seized together, making it extremely difficult or impossible to open the clamp to inspect or service the connection. L.J. Star had a decades-long business relationship with this customer, which made quickly tracking down the source of the problem and correcting it a high priority.

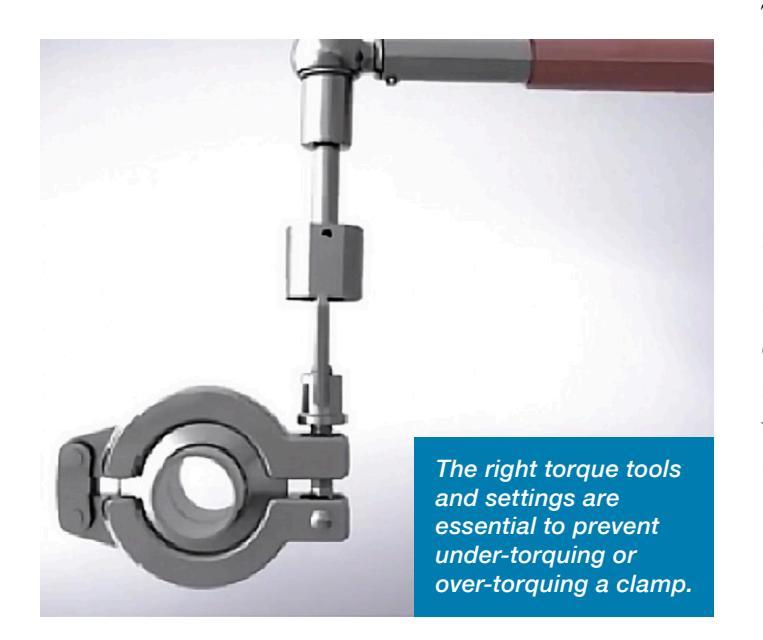
The first was the way maintenance personnel torqued the nuts that held the clamps in place around the ferrules. Under-torquing leads to a gasket that's under-compressed, making the joint prone to leaking and allowing for entrapment areas between the gasket and ferrule. When over-torqued, a clamp's bolts and nuts can fuse or bind to each other, so they are literally "cold-welded" together. Over-torqued clamps also exert too much friction and pressure on the connection, which can lead to gasket intrusions into the connection, interfering with the flow of

process material and allowing particles to collect. Over-torquing a clamp can even cause pieces of the gasket to shear off, contaminating the product.

After further research, we concluded the source of the problem could be traced to the materials from which the bolt and nut were formed. Like the rest of the clamp, they were made of 316 grade stainless steel. Being made of the same material caused them to fuse and seize when over-torqued or exposed to high temperature, friction and pressure. That meant that the key to the solution was making sure that the bolt and the nut were made of two different types of steel of differing levels of hardness. However, we realized that if the nut was formed of the harder material, it would strip the bolt if it was over-torqued, which would have required scrapping the entire clamp. Preventing galling required forming the bolts out of harder material that wouldn't be deformed by over-torquing the nut.

Through working with our local distributor, we soon discovered that our customer's maintenance personnel had no established torquing procedure or specifications to follow. That meant that any clamp could be significantly over-torqued or under-torqued, depending on the physical strength of the person who closed it. Although this wasn't determined to be the root cause of the customer's galling problem, it led them to develop a validated and approved set of torquing procedures and settings, as well as to purchase tools for applying and checking for the proper amount of torque.

SH Series clamps with the new antigalling option are constructed with bolts formed from Nitronic 60 stainless steel alloy to withstand over-torquing and sodium hydroxidebased cleaning solutions. They are now commercially available for use in pharmaceutical and biotechnology processing operations, as both original equipment and as replacement parts.
