# Analyzing the Root Cause of Clamp Galling Required Customer Cooperation

A few years ago, one of L.J. Star's major pharmaceutical manufacturing customers in New England began reporting galling problems with clamps. In a galled clamp, the threads of the bolt and nut become fused and seized together, making it extremely difficult or impossible to open the clamp to inspect or service the connection. L.J. Star had a decades-long business relationship with this customer, which made quickly tracking down the source of the problem and correcting it a high priority.

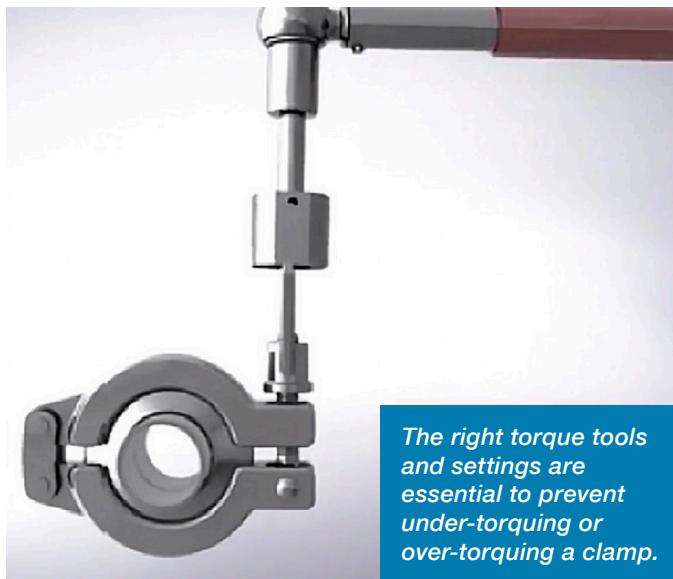
*The right torque tools and settings are essential to prevent under-torquing or over-torquing a clamp.*

The first was the way maintenance personnel torqued the nuts that held the clamps in place around the ferrules. Under-torquing leads to a gasket that's under-compressed, making the joint prone to leaking and allowing for entrapment areas between the gasket and ferrule. When over-torqued, a clamp's bolts and nuts can fuse or bind to each other, so they are literally "cold-welded" together. Over-torqued clamps also exert too much friction and pressure on the connection, which can lead to gasket intrusions into the connection, interfering with the flow of

process material and allowing particles to collect. Over-torquing a clamp can even cause pieces of the gasket to shear off, contaminating the product.

Through working with our local distributor, we soon discovered that our customer's maintenance personnel had no established torquing procedure or specifications to follow. That meant that any clamp could be significantly over-torqued or under-torqued, depending on the physical strength of the person who closed it. Although this wasn't determined to be the root cause of the customer's galling problem, it led them to develop a validated and approved set of torquing procedures and settings, as well as to purchase tools for applying and checking for the proper amount of torque.
